DESIGNATION OF HAZARDOUS DEVELOPMENT SITE

Fema/State Interagency Technical Report

Boise County Debris Flow January 1-3, 1997

ALLUVIAL FAN COMPLEX DEBRIS FLOOD/FLOW POTENTIAL

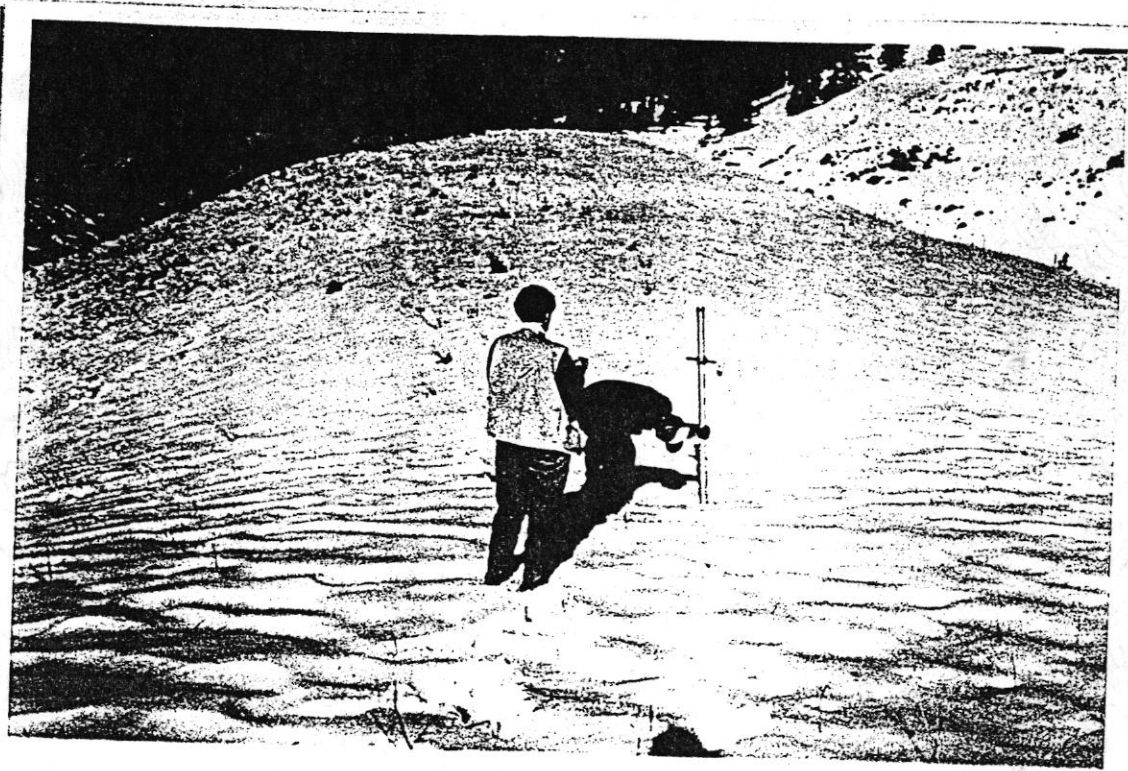
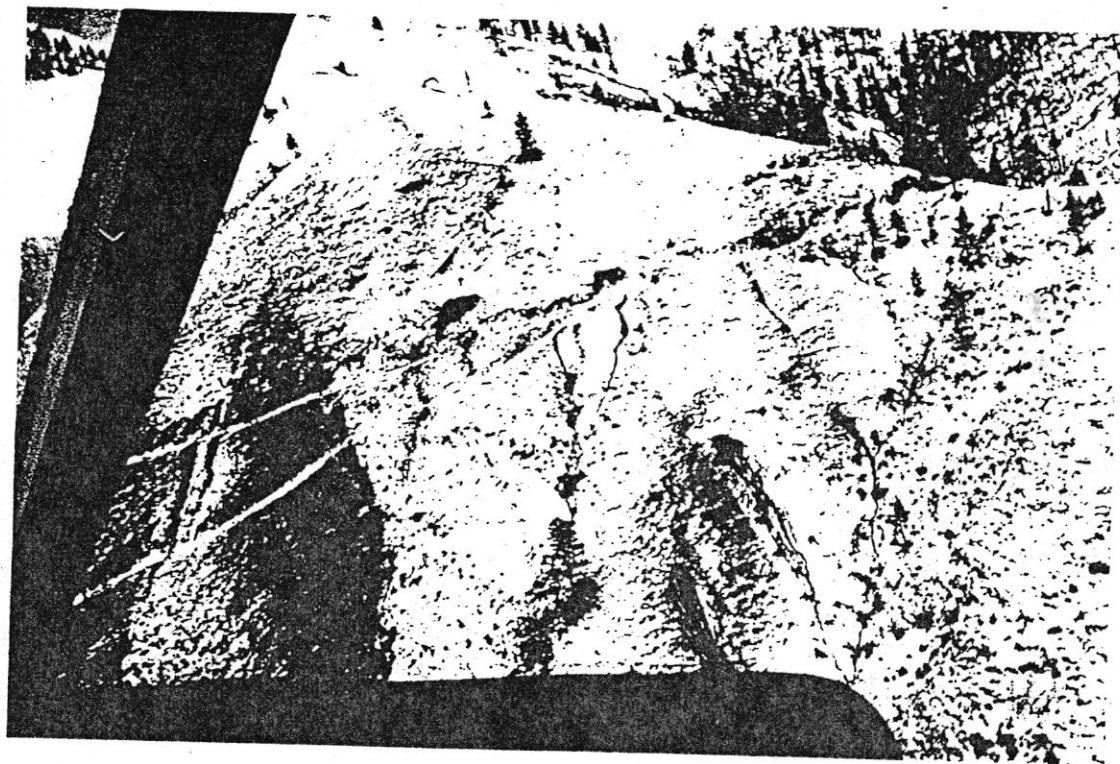
Top Photograph: Phil Morrisey (NRCS, Snow Survey Office) conducting snow survey in Lower Banks watershed. Lower Photograph: View of watershed areas above Lower Banks.

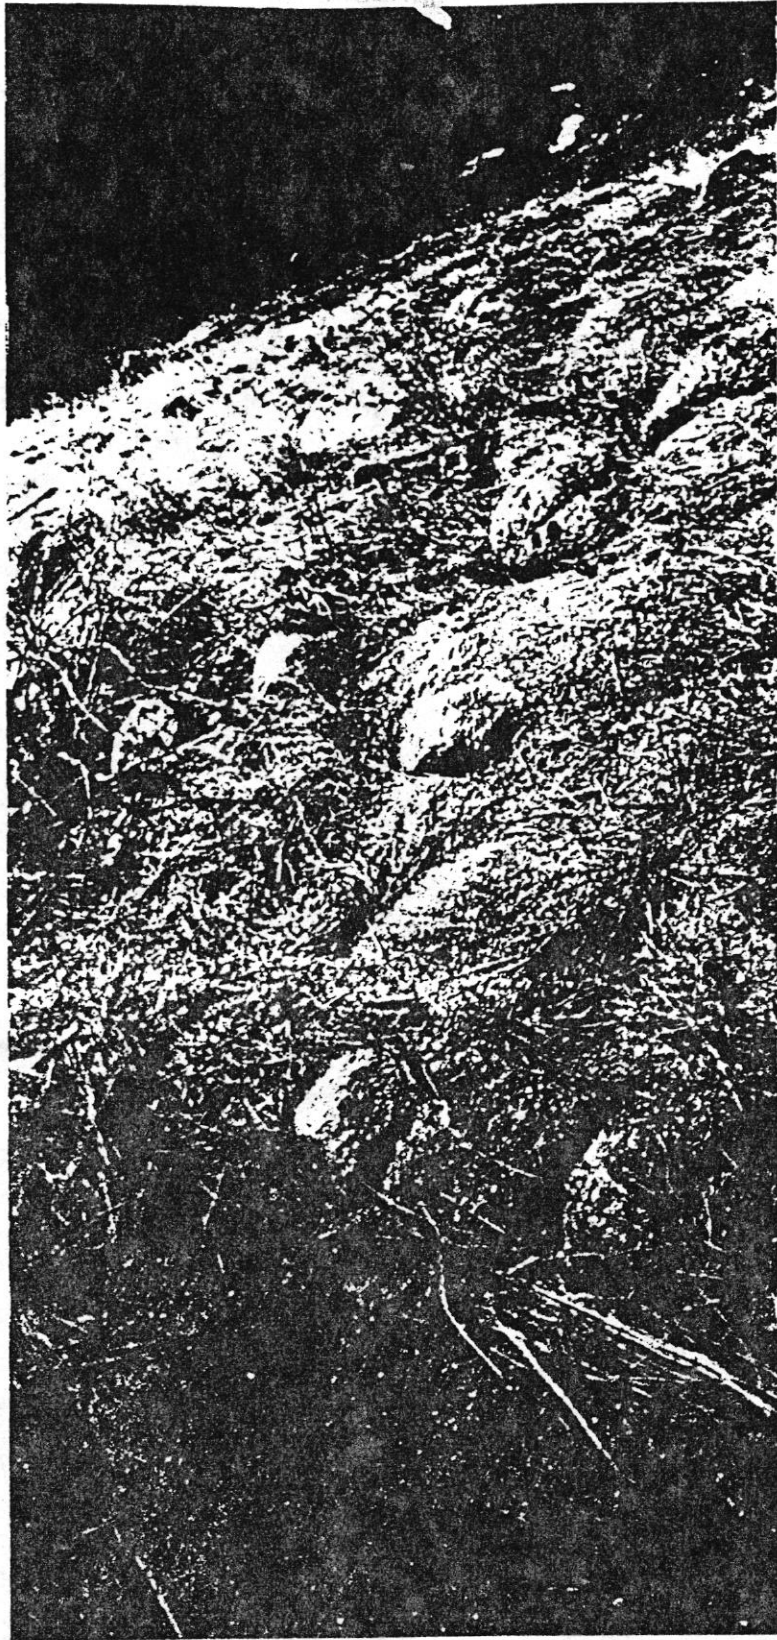
The canyon slopes also contain much boulder debris. This is the source for much of the boulder debris that ultimately emerges through the canyon mouth onto the alluvial fan. Each slump into the channel bottom will supply boulders that will ultimately be transported to the fan below. Boulders pose a significant threat to human life and property because their impact forces are considerably greater than are the forces of the water or mud against structures. It was concluded that these forces on this fan apex cannot be reasonably mitigated.

Boulders lodged in canyon wall soils in main watershed above Lower Banks.

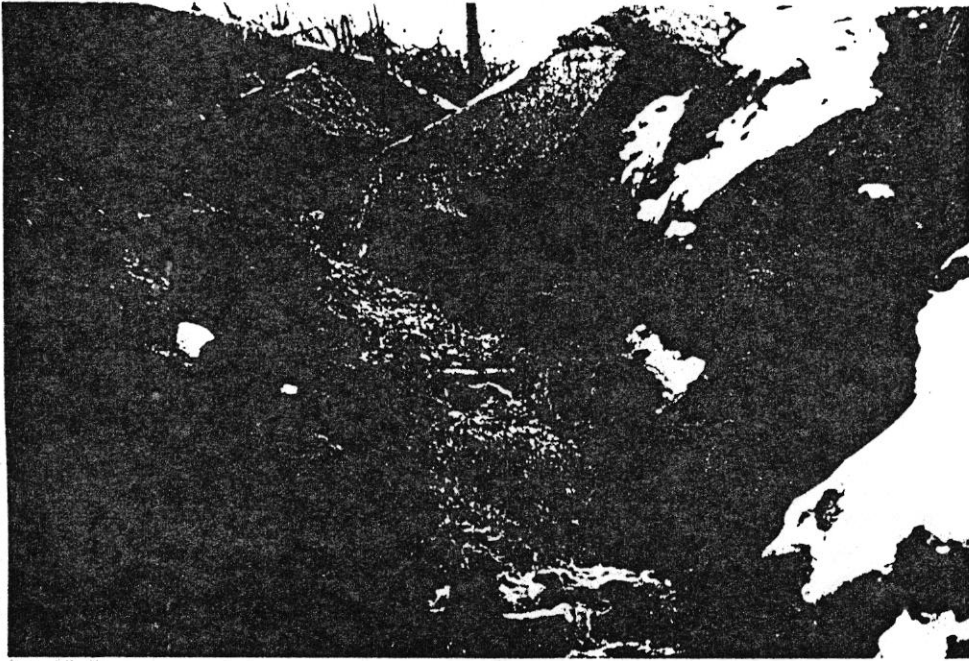
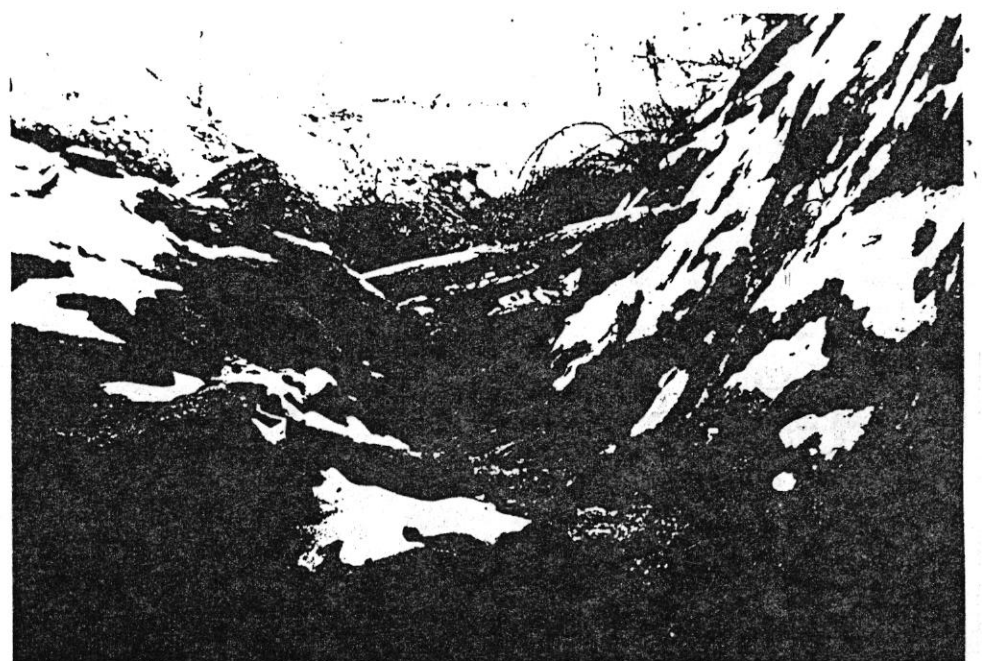
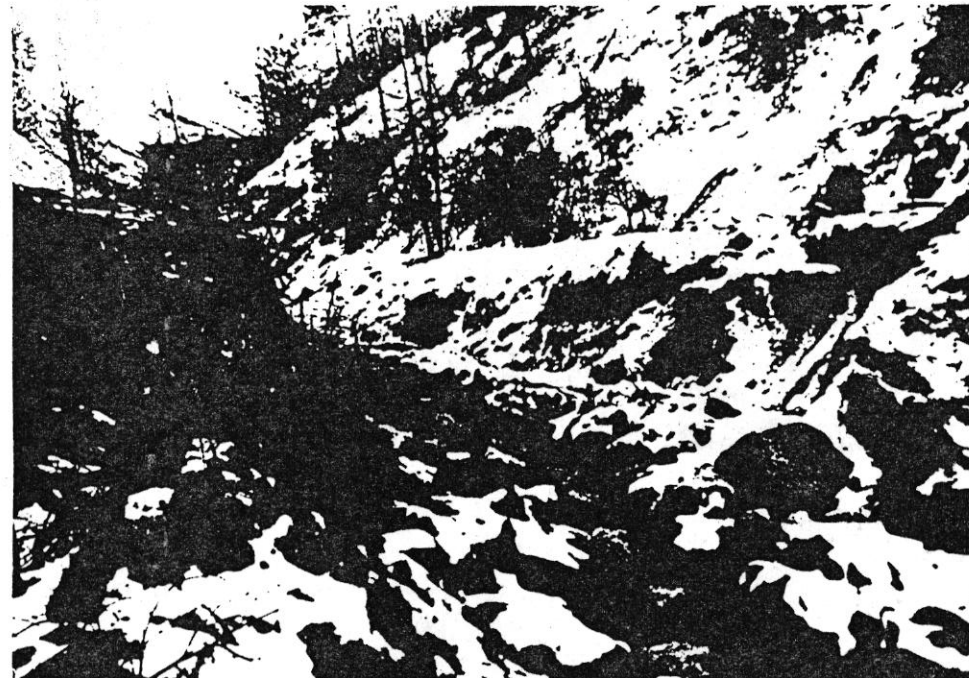
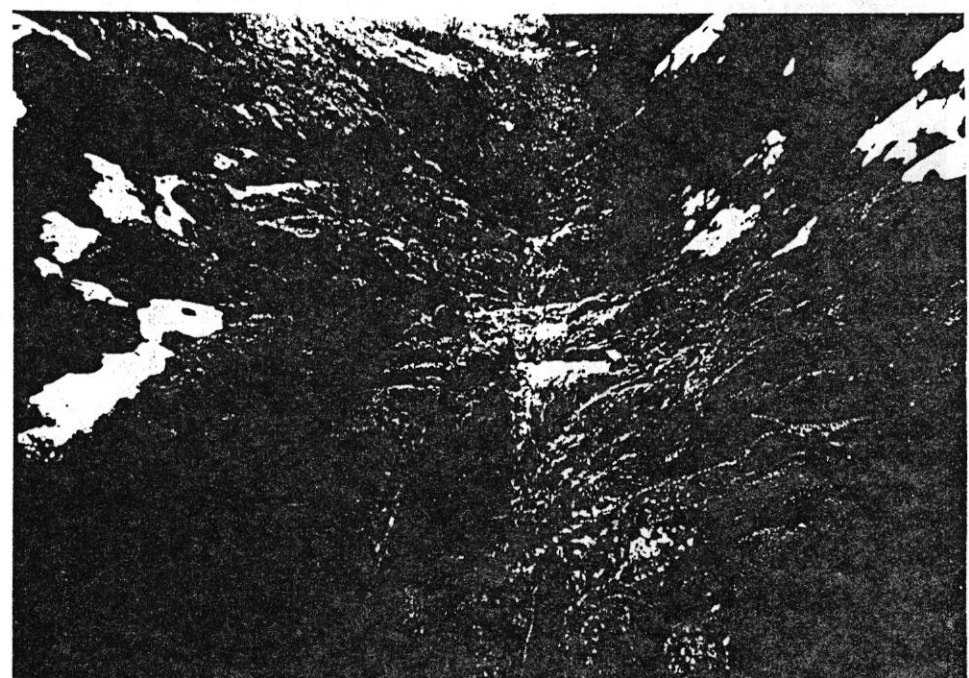
Photographs of boulders and bedrock in main channel of Lower Banks watershed.

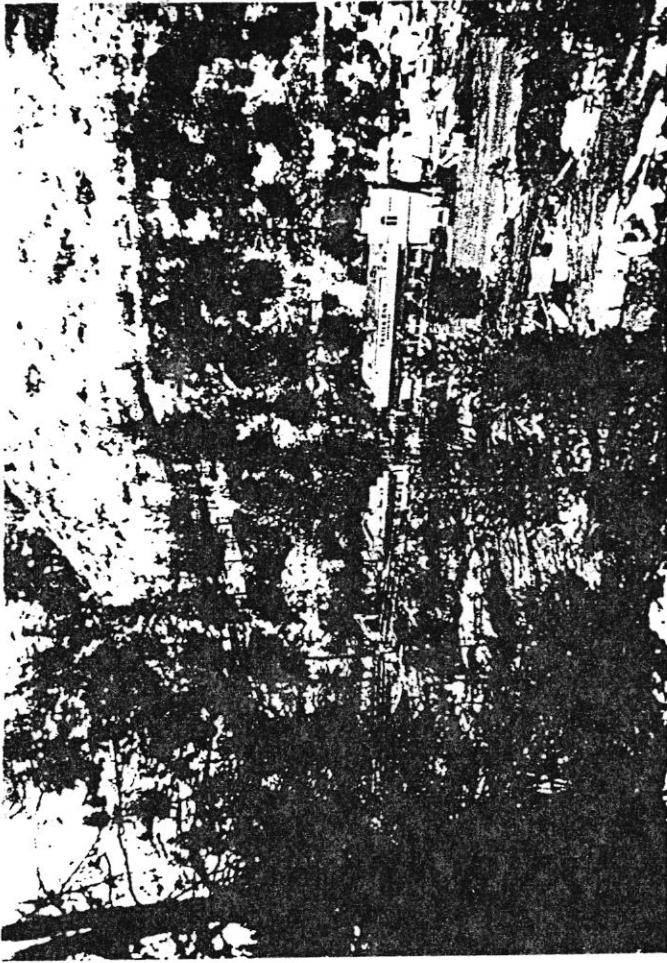
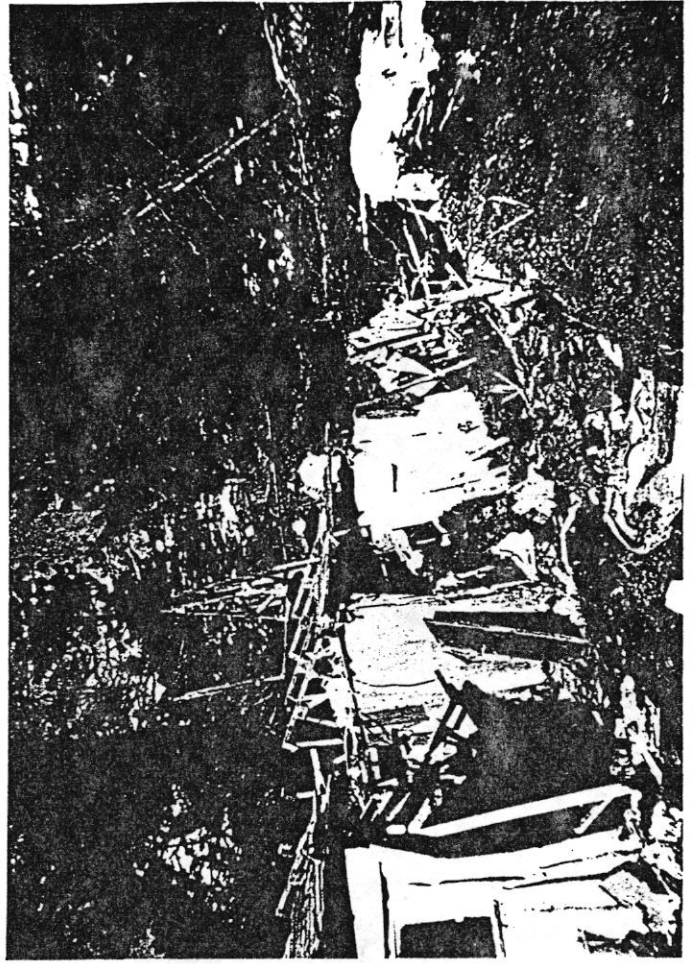
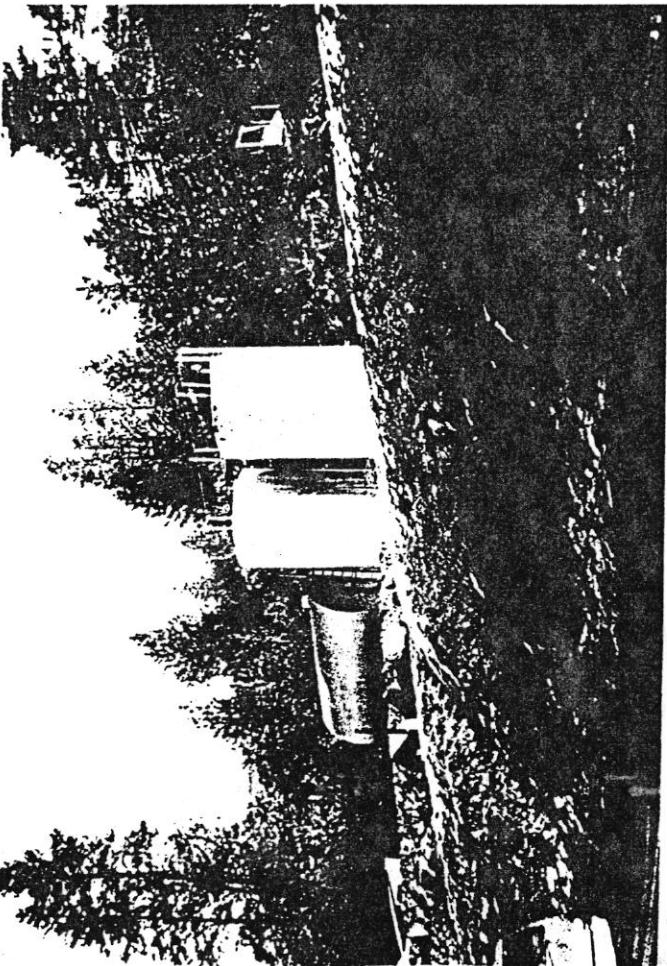
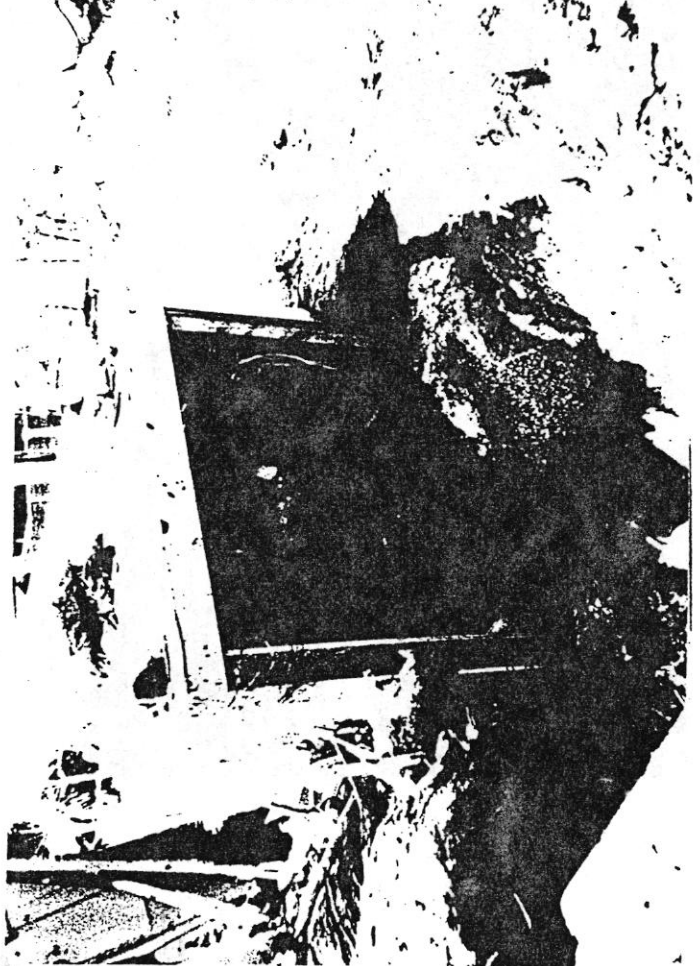
Photographs of risk and damage in Lower Banks area.

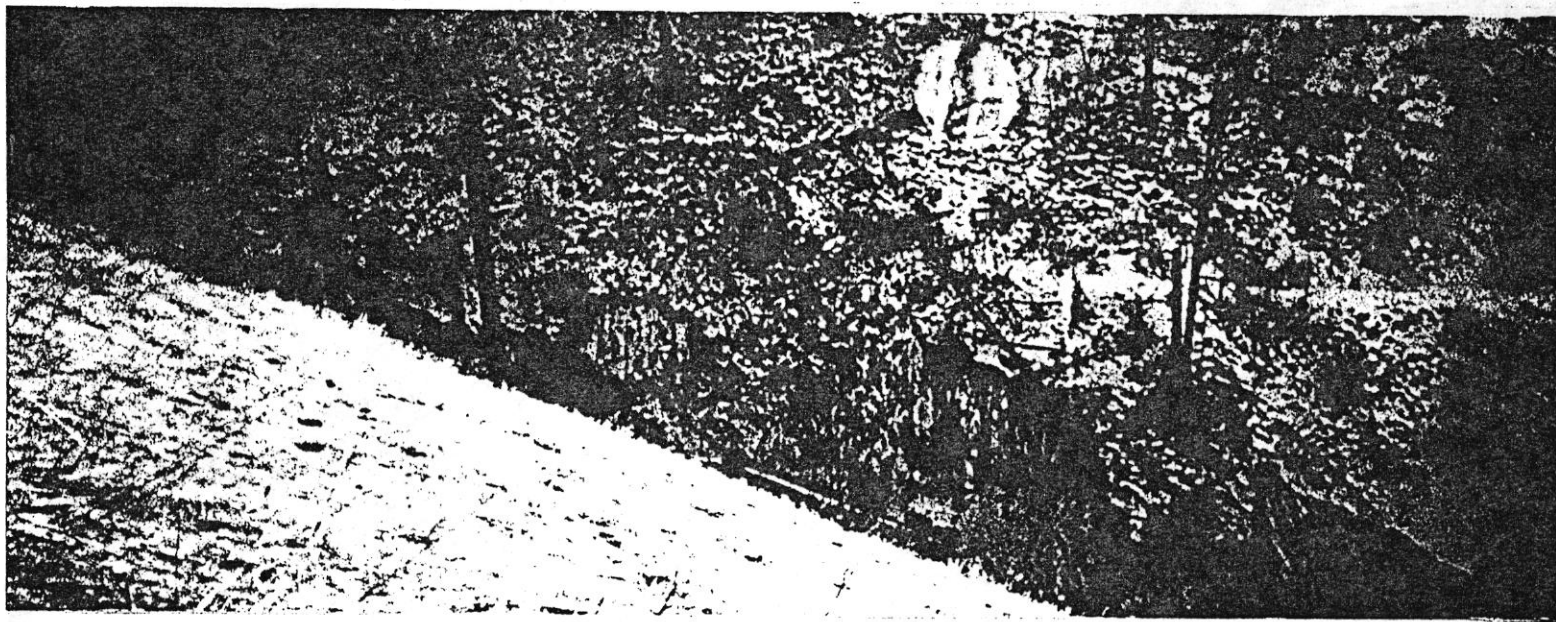
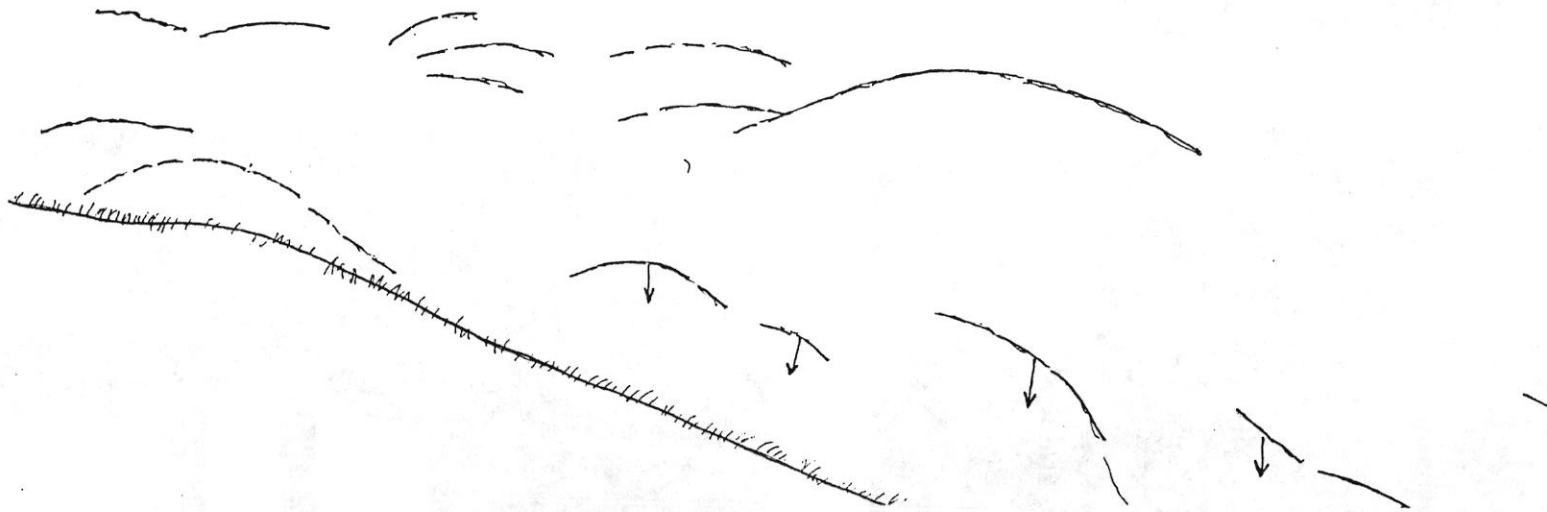
The snow-covered north-facing slopes are assumed to be underlain by frozen ground. This ground will thaw and will likely become unstable when that happens. The steeper slopes and more dense vegetation may contribute numerous slumps with tree debris into the channel bottom, which is assumed by the IAT to contribute to the ongoing imminent threat to human life below on the fan apex—in a sense, the second "barrel" of a "double-barrel shotgun."

TOP: Panoramic photograph of the north-facing slope of the main canyon above Lower Banks. Note the slump scarps in frozen soil. Undercut lower slopes slumped into the stream bottom, as shown. BOTTOM: Outline sketch of scarps shown in photogrpah above.
